DEBOCHE NUNNERY
2016 - BUILDING & SITE UPDATES
 *BASED ON PHOTOS TAKEN BY JOE SWAN (AWB) (AS SITE TRIP) ON TRIP TO BIO-GAS PROJECT SITE

APRIL 2016

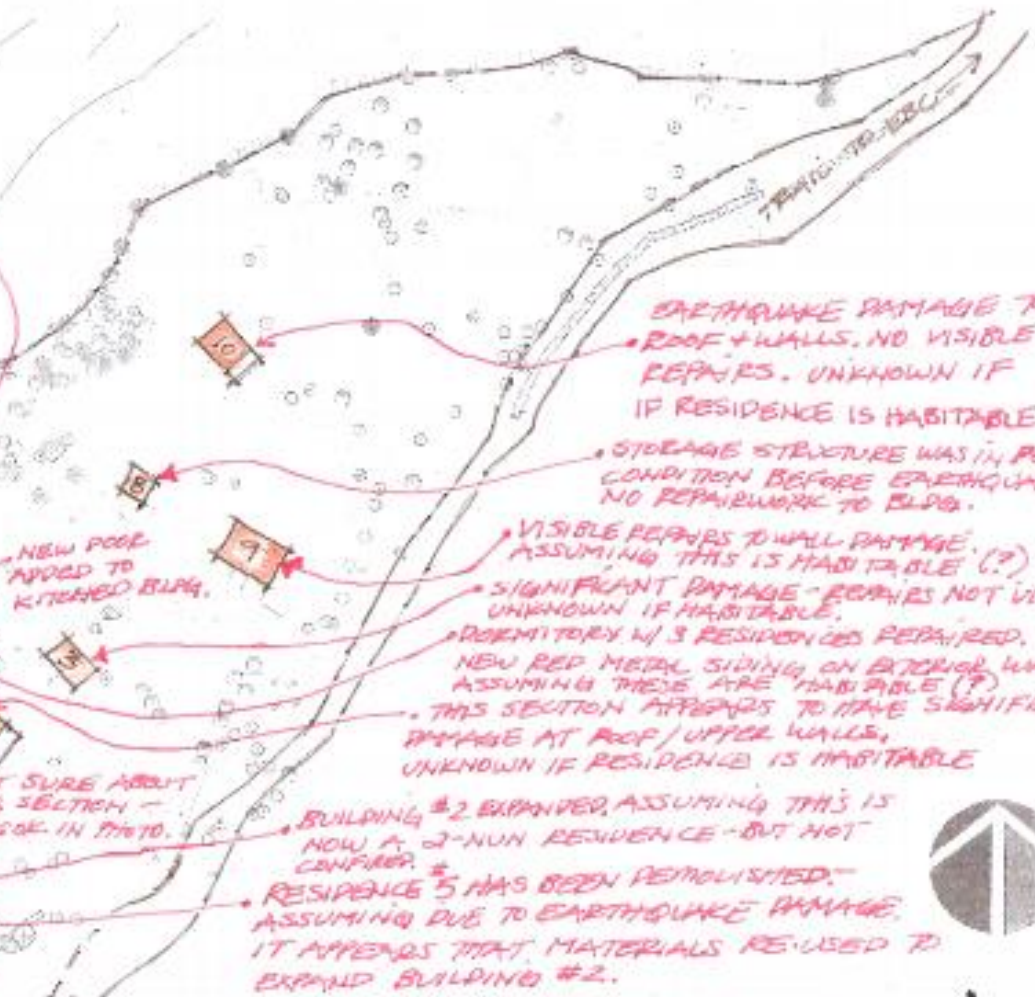
THIS RESIDENCE WAS ALREADY IN VERY POOR CONDITION BEFORE EARTHQUAKE. APPEARS UNINHABITED AFTER FURTHER EARTHQUAKE DAMAGE. APPEARS UNINHABITED BUT NOT CONFIRMED, NO REPAIR WORK OBSERVED

PRAYER HALL, COURTYARD + FRONT ENTRY IN MIDST OF SIGNIFICANT RECONSTRUCTION

PRAYER WHEEL BUILDING PARTIALLY REPAIRED. NORTH WALL HAS LARGE WHOLE COVERED WITH PLASTIC SHEETS

CONDITION OF LARGE PRAYER WHEEL UNKNOWN

DAMAGED TOILET STRUCTURES HAVE BEEN RE-BUILT

DAMAGED RESIDENCE #6 REPAIRED + NOW USED AS PRAYER ROOM. TENT IN FRONT SERVES AS VESTIBULE

FORMER ANI-FEMAS RESIDENCE RE-BUILT AFTER SIGNIFICANT EARTHQUAKE DAMAGE

EARTHQUAKE DAMAGE TO ROOF + WALLS. NO VISIBLE REPAIRS. UNKNOWN IF RESIDENCE IS HABITABLE.

STORAGE STRUCTURE WAS IN POOR CONDITION BEFORE EARTHQUAKE. NO REPAIR WORK TO BLDG.

VISIBLE REPAIRS TO WALL DAMAGE. ASSUMING THIS IS HABITABLE (?)

SIGNIFICANT DAMAGE - REPAIRS NOT VISIBLE UNKNOWN IF HABITABLE.

DORMITORY W/ 3 RESIDENCES REPAIRED.

NEW RED METAL SIDING ON EXTERIOR WALLS. ASSUMING THESE ARE HABITABLE (?)

THIS SECTION APPEARS TO HAVE SIGNIFICANT DAMAGE AT ROOF / UPPER WALLS. UNKNOWN IF RESIDENCE IS HABITABLE

BUILDING #2 EXPANDED, ASSUMING THIS IS NOW A 2-NUN RESIDENCE - BUT NOT CONFIRMED.

RESIDENCE #5 HAS BEEN DEMOLISHED. ASSUMING DUE TO EARTHQUAKE DAMAGE. IT APPEARS THAT MATERIALS RE-USED TO EXPAND BUILDING #2.
